Sewickley Bridge  
(Bridge #1 Ohio River) ~~(now destroyed)~~  
Spanning the Ohio River  
Sewickley  
Allegheny County  
Pennsylvania

HAER No. PA-53

## Bridge #1 Ohio River (Sewickley Bridge)

Historian: Pennsylvania Department of Transportation, February 1978.

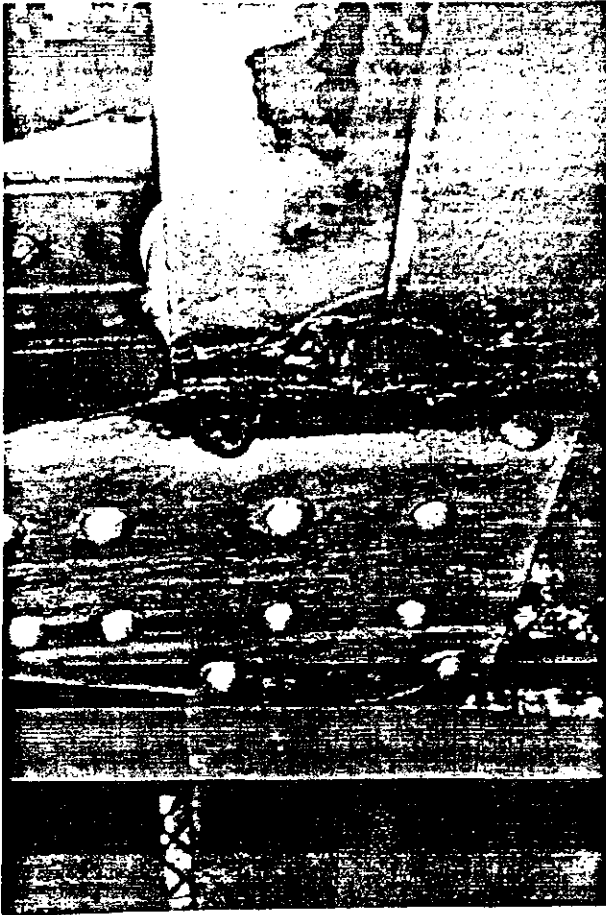
Span 3, West Truss, bottom chord, p.p. L1.  
Look north. Photo D8.

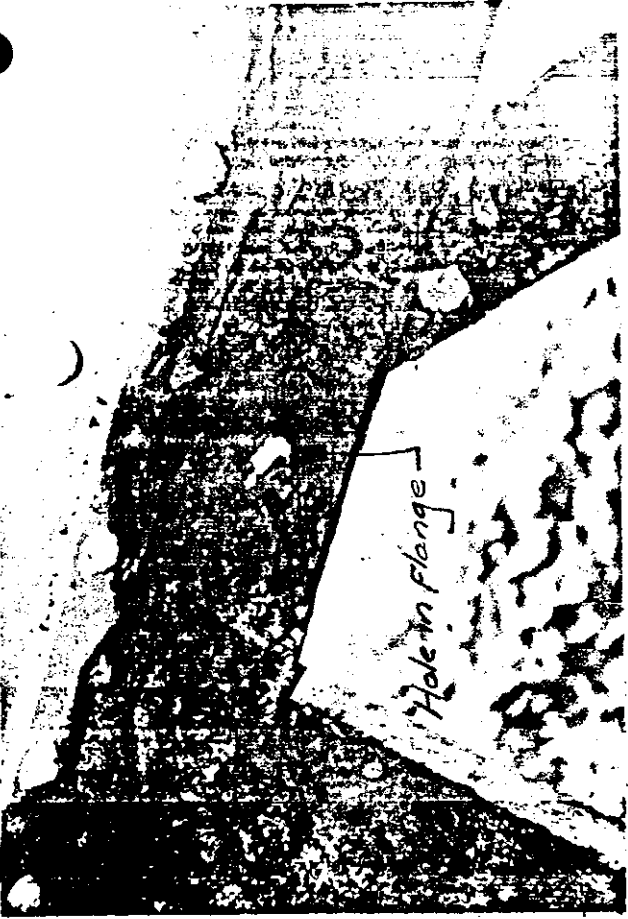
Bottom flange east angle west most flange of the bottom chord, east truss, north of p.p.L12. Photo K8.

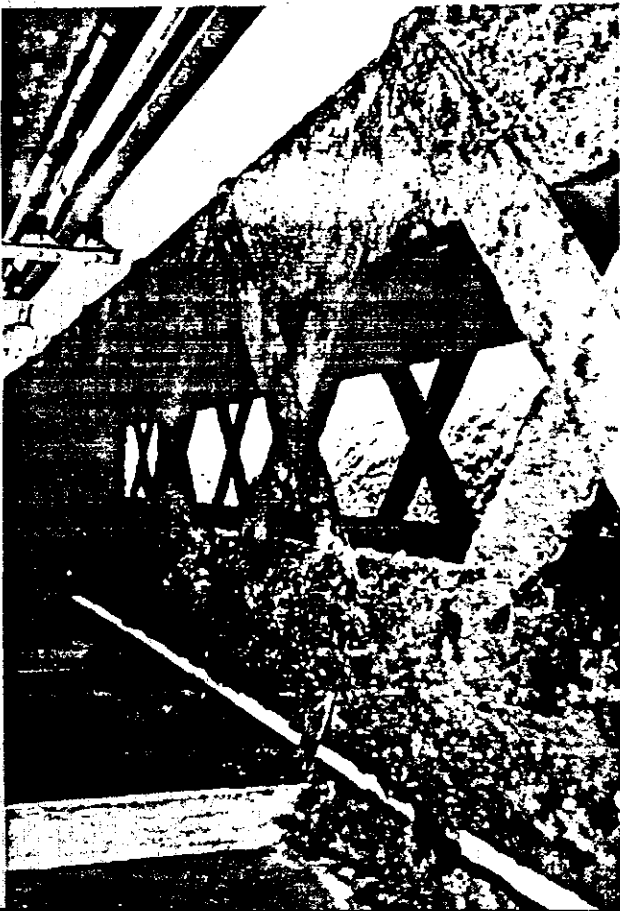
Top lacing bottom chord, east truss between p.p.L13L14. Photo K1.

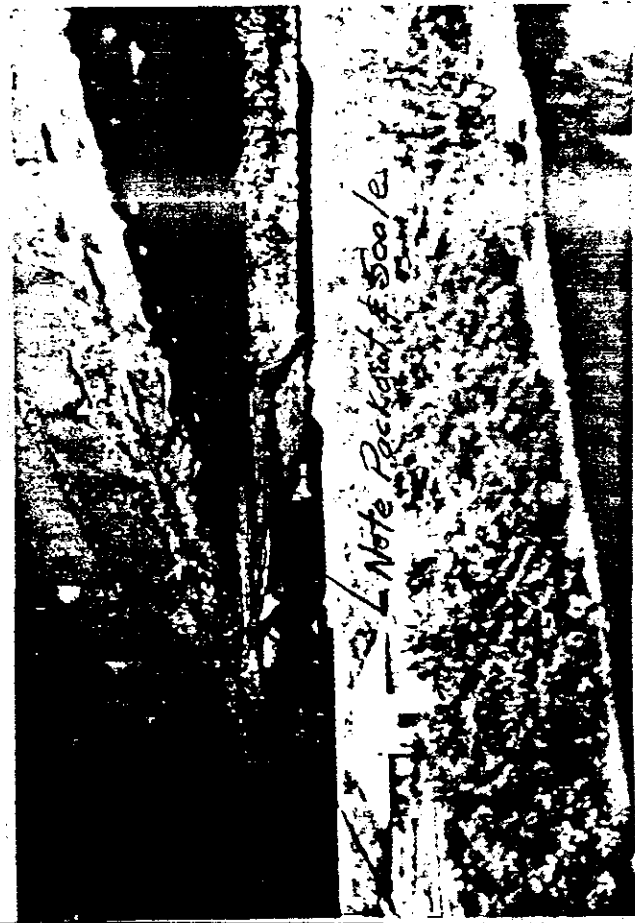
Bottom lacing connection, bottom chord, east truss between p.p.L3L32. Photo C15.

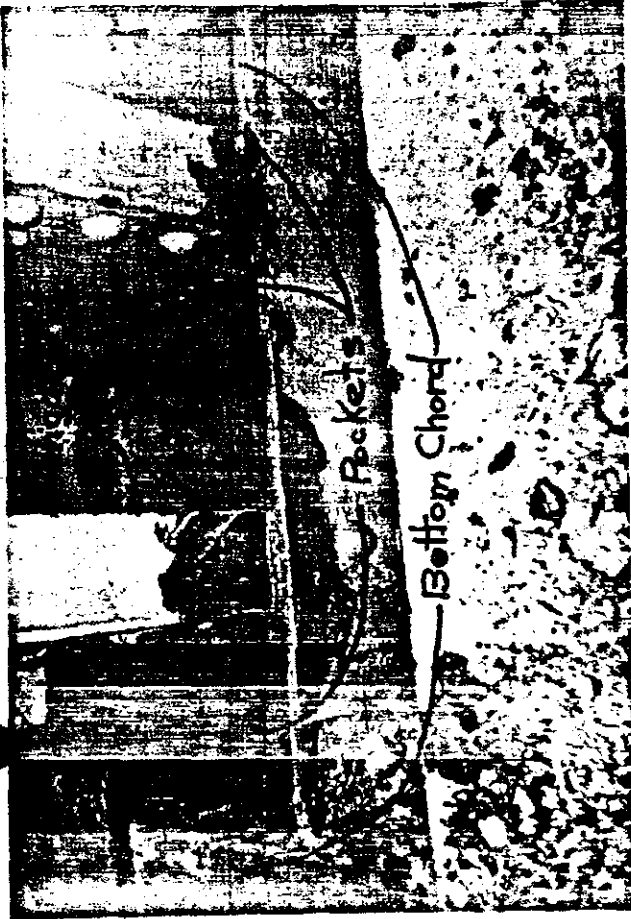
East truss, p.p.L17 south side, post angle at west web. Look north. Photo J18.

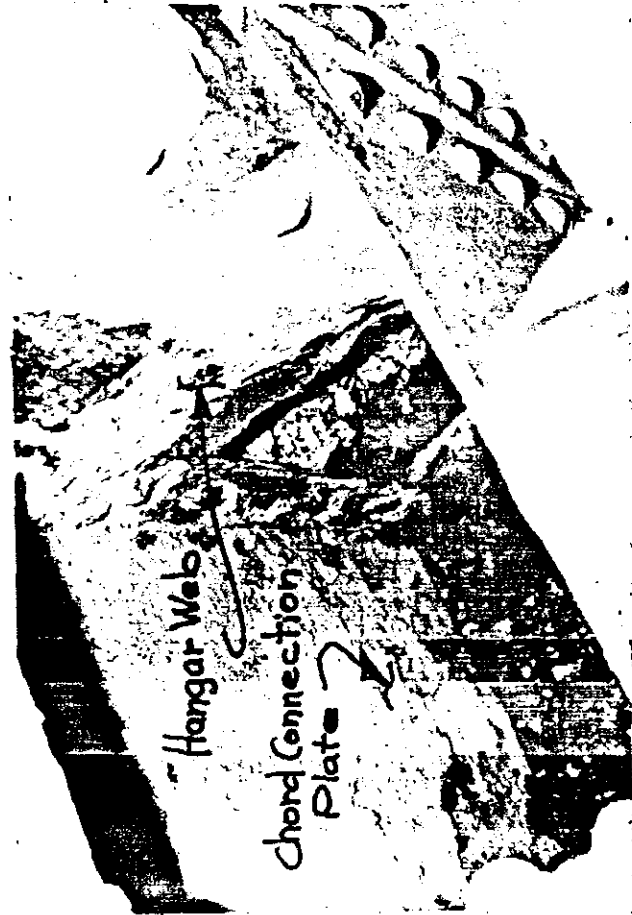
West truss at p.p.L43 west web of vertical (note hole in web). Photo L12.

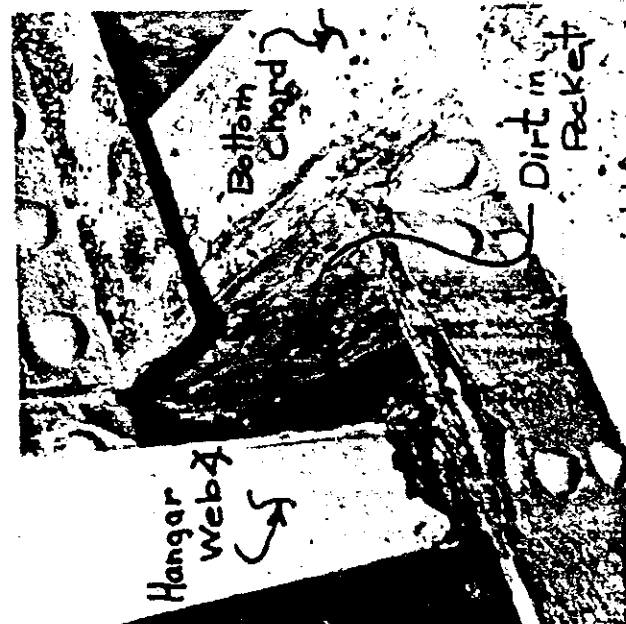
East truss bottom chord at p.p.L17 (note debris & corrosion). Photo K3.

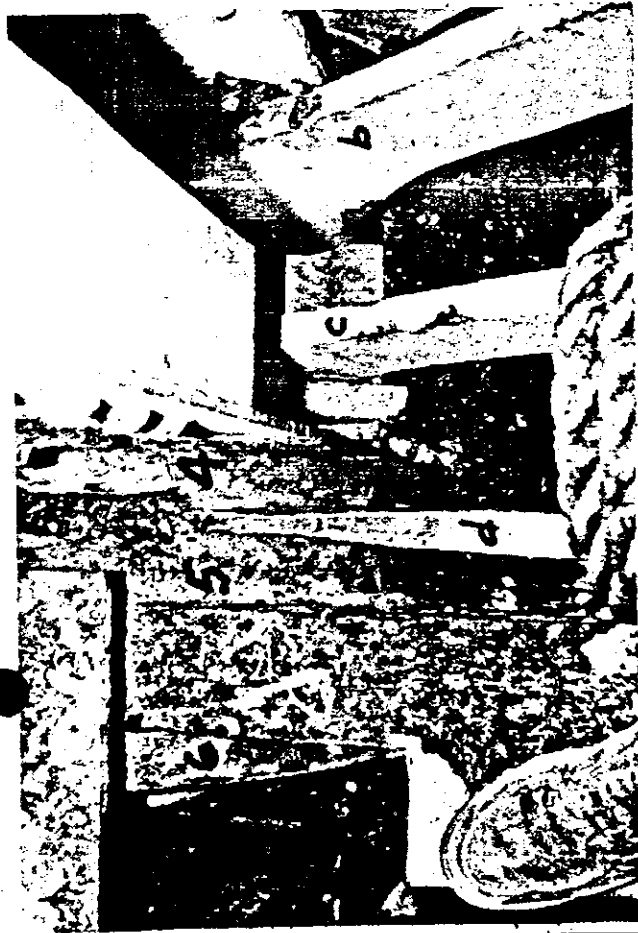
East truss, p.p.L22 south side, diagonal eyebar marked "d", thickness = 1/2". Look down and north. Photo F1.
